Manhole Inspection Summary

Manhole # S51M__021MH

Insp Date: **4/4/08 10:04 AM**

Location Address: **rear 2930 odonnell st**

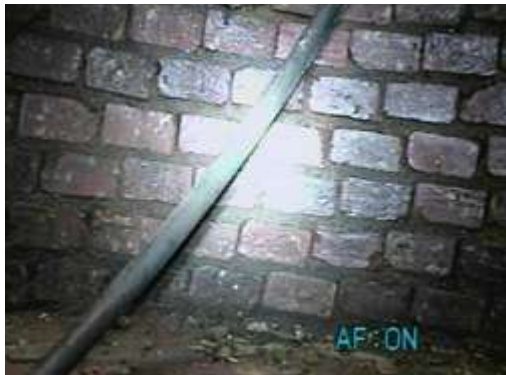
Miscellaneous

bench debris

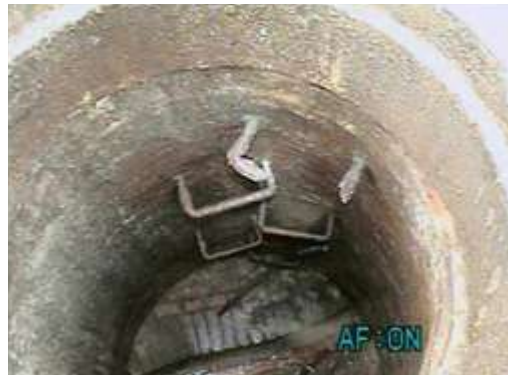
Defect 2

Steps Count: **5** Missing: **1** ☒ **Corroded**

steps

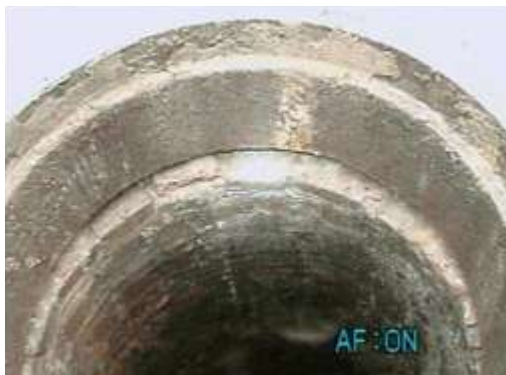
Defect 1

Frame Offset: **1.5** (in.) Condition: ☒ Sound ☐ Cracked ☐ Leaks

offset

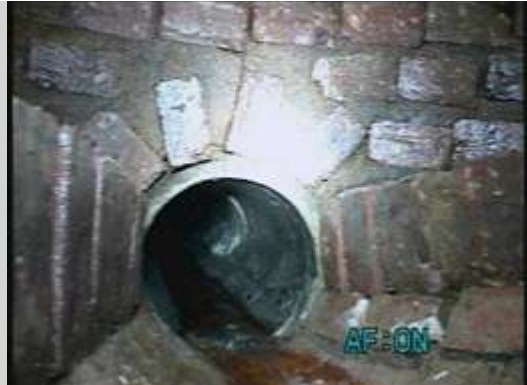
12 O'Clock Outflow

8 in. Circular Gravity Sewer
Pipe Out @ 12 O'Clock

Pipe Material: **Clay** ☐ Pipe Lined

Invert Depth: **9.90** (ft.) Flow Characteristics: **Fast**

Infiltration: **None** Pipe Seal Cond: **Sound**

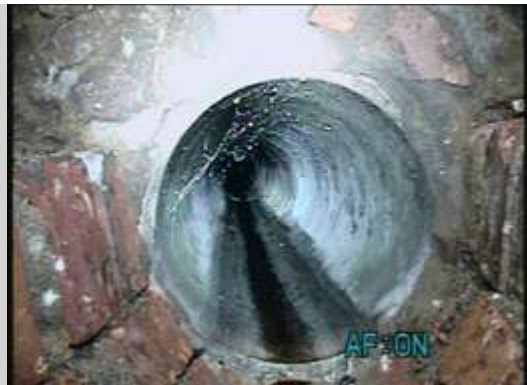
3 O'Clock Inflow

8 in. Circular Gravity Sewer
Pipe In @ 3 O'Clock

Pipe Material: **Clay** ☐ Pipe Lined

Invert Depth: **9.00** (ft.) Flow Characteristics: **Fast**

Infiltration: **None** Pipe Seal Cond: **Unknown**

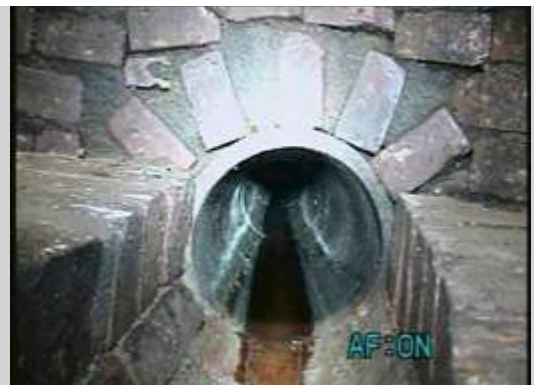
6 O'Clock Inflow

8 in. Circular Gravity Sewer
Pipe In @ 6 O'Clock

Pipe Material: **Clay** ☐ Pipe Lined

Invert Depth: **9.83** (ft.) Flow Characteristics: **Fast**

Infiltration: **None** Pipe Seal Cond: **Broken**
